Construction Work Plan  
Sheet Pile Repair  
Metal Bank Cottman Avenue  
Superfund Site

On behalf of:  
**Cottman Avenue PRP Group**

Prepared by:  
**ENVIRON International Corporation**  
**Boston, Massachusetts**

Date:  
**April 2015**

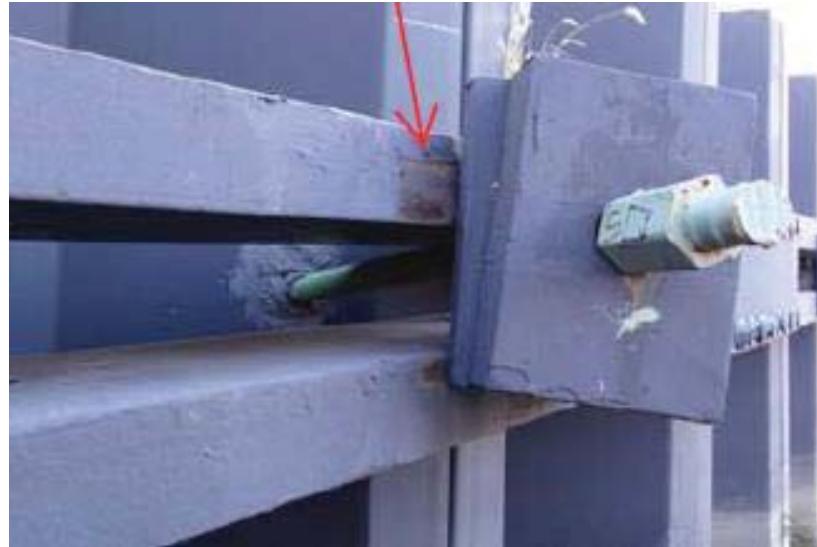
- The north side of Zone 1 shows movement of the sheet pile wall system. The epoxy coating on the face of the wale has been scraped and removed providing evidence that the tieback plates have moved relative to the wale.

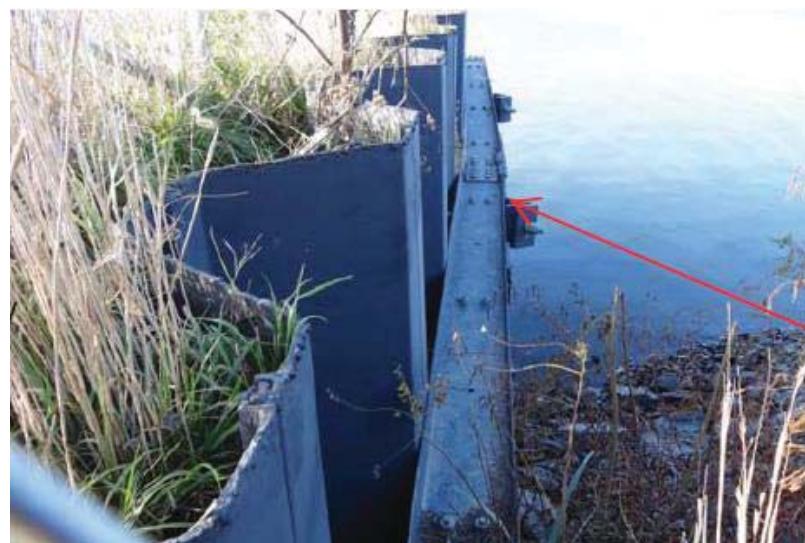
In addition, the wale and sheet pile wall appear to be bowing with the apex of the bow at the bolted connection and there appears to be additional movement of the tieback plates relative to the wale.

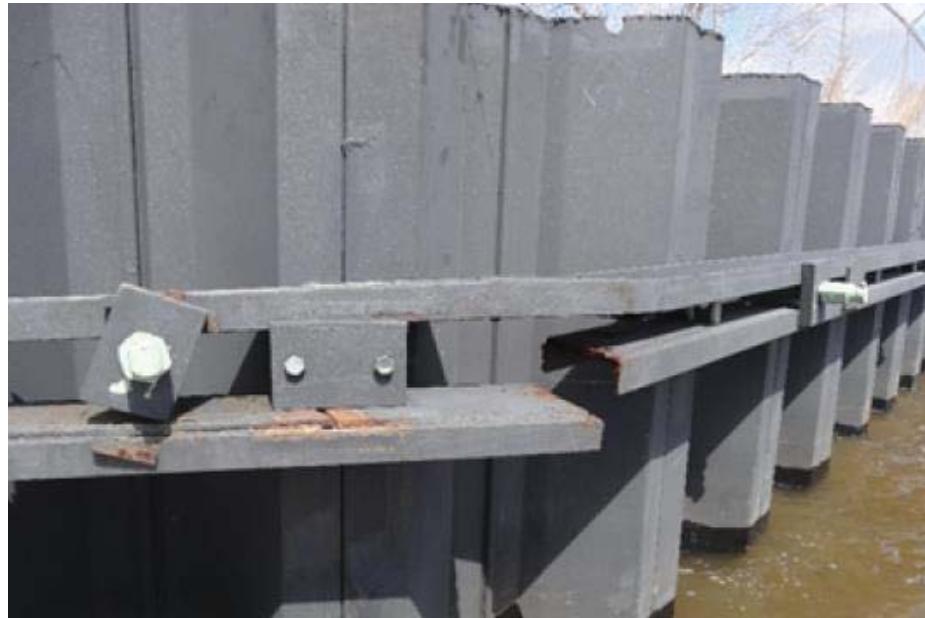
- Cracks and separation of the wale were observed where the sheet pile wall changes direction (turns east) in Zone 2. The miter cut and joint where the wales meet at the corner was cracked. The cracks appear to be stress (tension) cracks. The wale cracked (failed) at this location due to movement of the wall toward the river.

The approach consists of two components: (1) to place rip rap on the river side of the sheet pile wall to provide additional support, and (2), to repair the portions of the waler that have failed. These repairs will address both the structural and global stability of the sheet pile wall under low water conditions and eliminate further movement of the wall. A schematic of the proposed repairs is shown below, though the detailed approach and means and methods for the required repairs and rip rap placement are to be determined by the contractor.

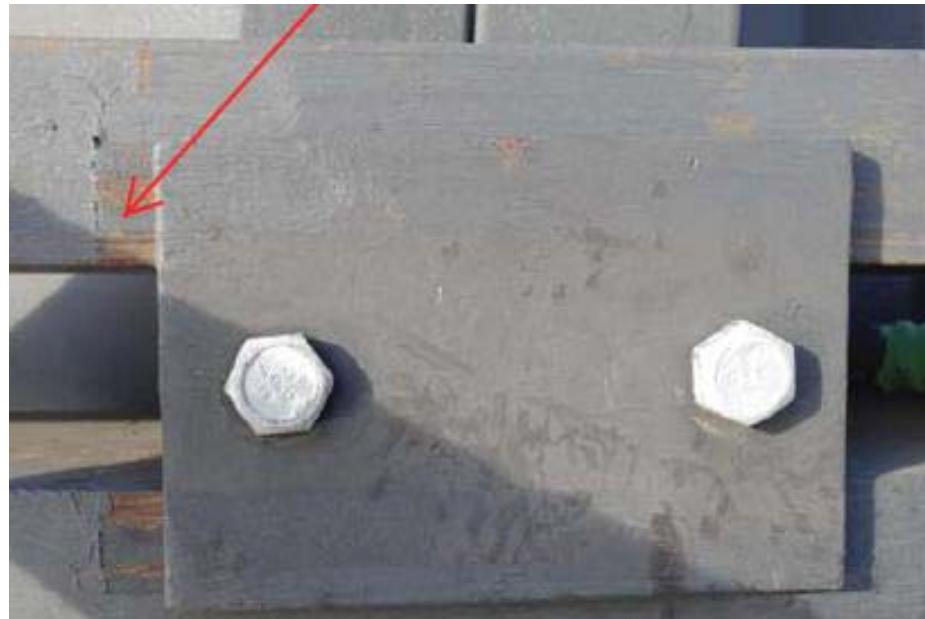
- The west side of Zone 3 shows signs of movement of the sheet pile wall system. The epoxy coating on the face of the wale has been scraped and removed providing evidence that the plates have moved relative to the wale.
